## Background

## Solution

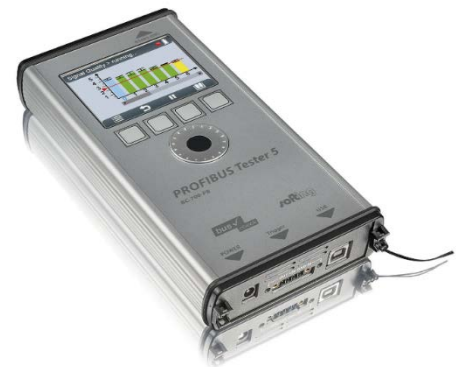
[Softing's PROFIBUS Tester 5](#) was specified by Jake Grainger, the owner, and implemented by Thomas Guerard (Mechatronics Engineer) and Charles Comeau (Controls Engineer). “The PROFIBUS Tester 5 was connected to each of our modules giving us an instant and easy to read conclusion.”

“We tested the main electrical cabinet with everything in the cabinet looking correct, but all the modules in the machine were barely registering. We then quickly connected to each of the modules at the machine and noticed that those modules all now had great readings and the cabinet was the one with the questionable modules. So, with the meter's ability to tell us the order of the modules and the length of those cables between them, we were able to pinpoint just which cable and connector was causing the problem.”
