Background

[Alpha Grainger](#) specializes in producing high-precision turned parts manufactured in top of the line CNC machines supplying a variety of industries such as aerospace, medical, military, and automotive fields to name a few.

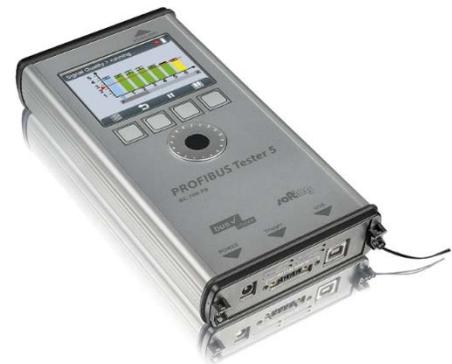
[Softing's PROFIBUS Tester 5](#) was specified by Jake Grainger, the owner, and implemented by Thomas Guerard (Mechatronics Engineer) and Charles Comeau (Controls Engineer). “The PROFIBUS Tester 5 was connected to each of our modules giving us an instant and easy to read conclusion.”

“We tested the main electrical cabinet with everything in the cabinet looking correct, but all the modules in the machine were barely registering. We then quickly connected to each of the modules at the machine and noticed that those modules all now had great readings and the cabinet was the one with the questionable modules. So, with the meter's ability to tell us the order of the modules and the length of those cables between them, we were able to pinpoint just which cable and connector was causing the problem.”

“This has been an ongoing issue that several people have pursued. Numerous items had been replaced, and countless hours wasted trying to solve this. All our testing with the [PROFIBUS Tester 5](#) took under an hour, including the time it took for us to figure out the functions we were going to use. We were able to get a machine back to 100% capacity that was running an extremely time sensitive job for a customer that was in immediate need of parts.”
